Annual CCR Landfill Inspection Coal Combustion Residual Rule Compliance

Facility
Healy Power Plant
2.5 Mile Healy Spur Road
Healy, Alaska

December 2020

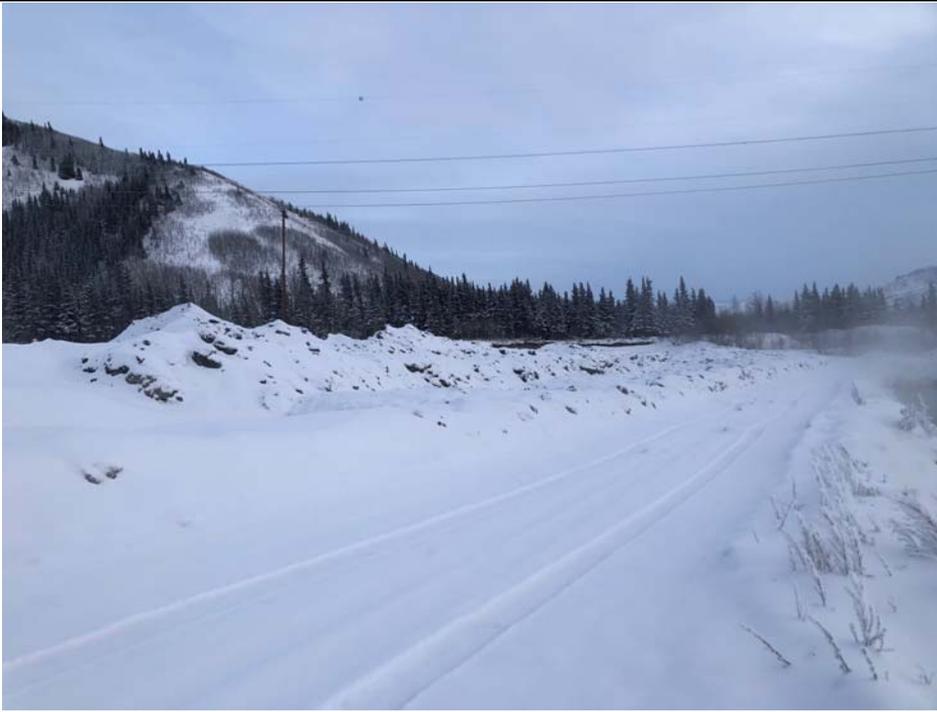
Looking east, ash drying trench and pile to the left. Edge of pond to the right.

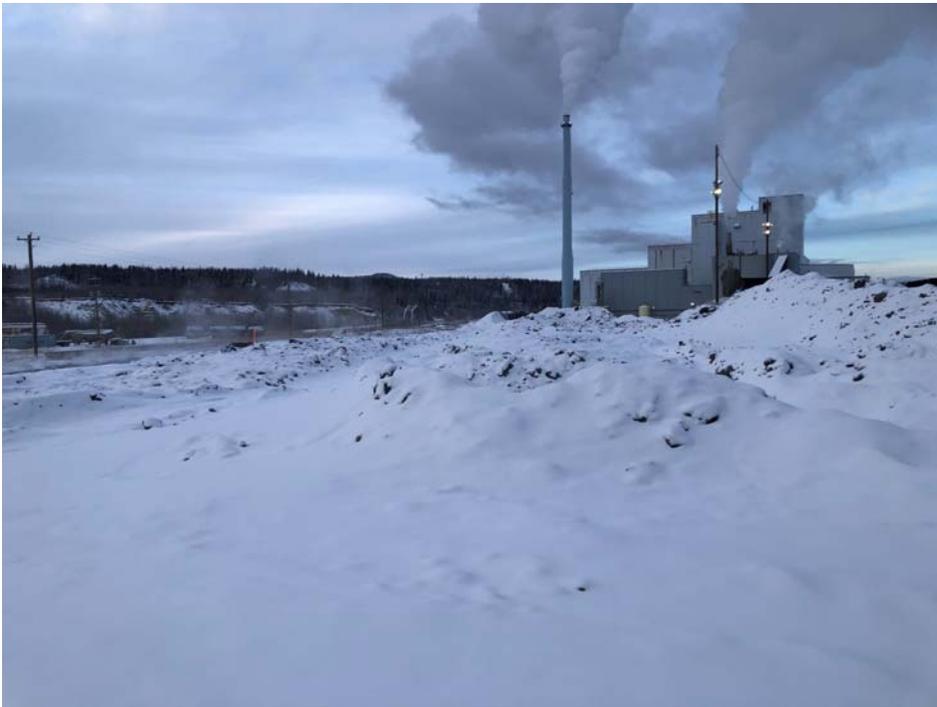
Looking west at the drying trench and pile.

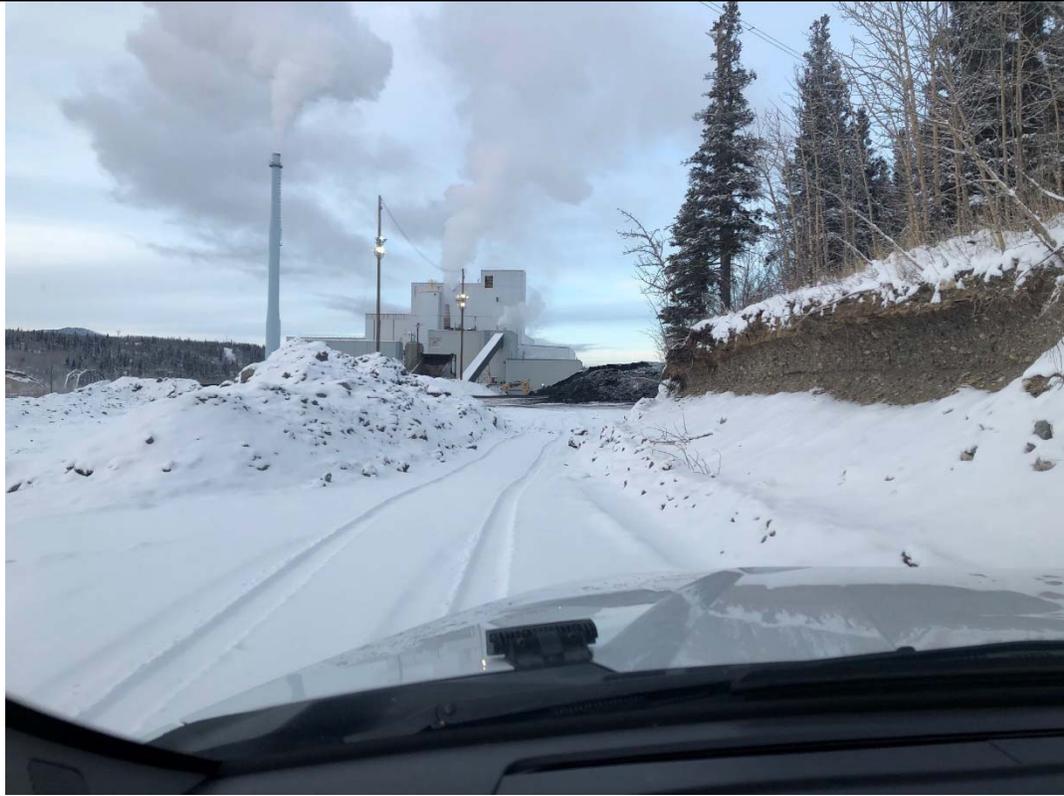
Looking northwest, far east edge of ash pile and looking at the coal pile.
